August 23, 2011

An Open Letter to Metro-North Railroad Customers

*A Review of the Actions Taken by Metro-North
Railroad in Response to
Multiple Heat-Related Incidents on the
New Haven Line
July 22, 2011*

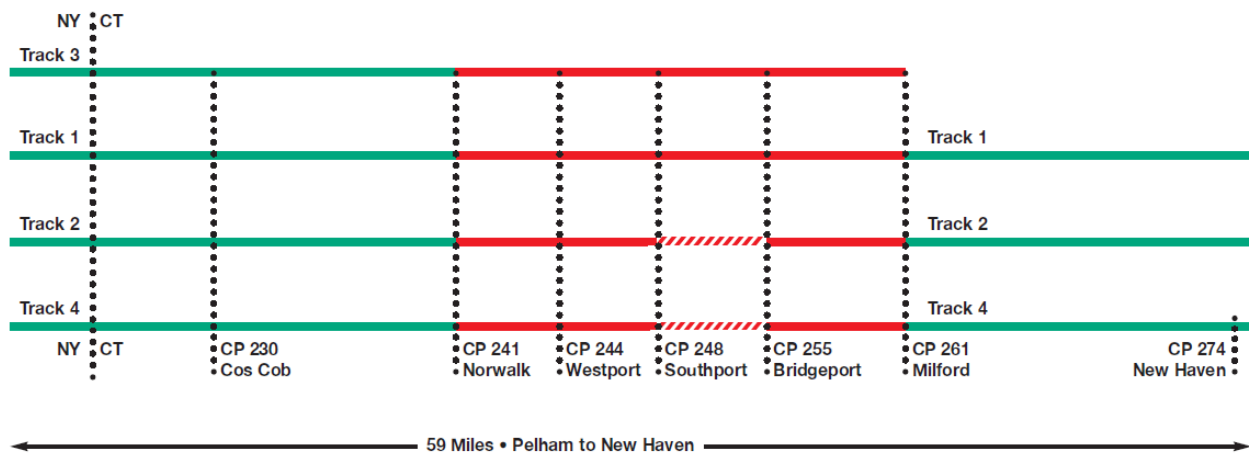
Current Status of New Haven Line Catenary System

Portions of the overhead catenary system on the New Haven Line date to 1914. A key feature of this old catenary system is that it is prone to failure in either extreme heat ("sagging wire") or extreme cold ("brittle wire"). Specifically, when wires are sagging, they can become tangled in the "pantographs" -- the mechanical arms on the top of the cars that collect the power and provide it to the train -- both disabling the train and potentially tearing down wires that require sections of track to be taken out of service for lengthy periods of time.

CDOT commenced its catenary replacement in 1996. Completion is planned for 2015. Today, of the 172 miles of catenary on the New Haven Line in the State of Connecticut, 60% is the new constant tension system and 40% is either the original antiquated system or out of service for repair. MNR's operation is particularly vulnerable in the 7-mile stretch between Southport and Bridgeport. Of the four tracks in that area, 2 tracks are out of service for catenary replacement and bridge work; all trains, therefore, must operate on the other two tracks under old catenary. This system is decades past its useful life and the fragile condition of the system leads to regular failures, significantly impacting service reliability.

- █ New Catenary
- █ Replacement Underway (tracks out-of-service for trains)
- █ Old Catenary Circa 1914

Status as of 8/11
