Appendix L: Corridor Level Phase I ESA - Section 2

STATEN ISLAND NORTH SHORE BUS RAPID TRANSIT (BRT) SYSTEM – SECTION 2
NORTH SHORE OF STATEN ISLAND, NEW YORK
BETWEEN JERSEY STREET AND ALASKA STREET

Contract No. CM-0143
SSE No. 0000189595

DECEMBER 6, 2019

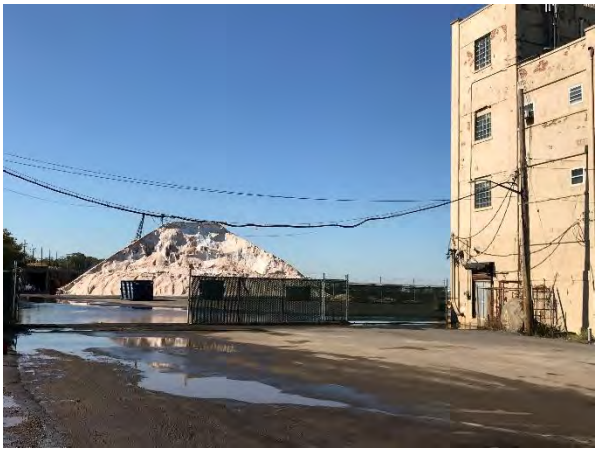
Photo 1: Eastern portion of the Atlantic Salt property, located: on; and, adjacent to, the eastern portion of the Proposed Alignment of Section 2, in subsection 2A, facing west.

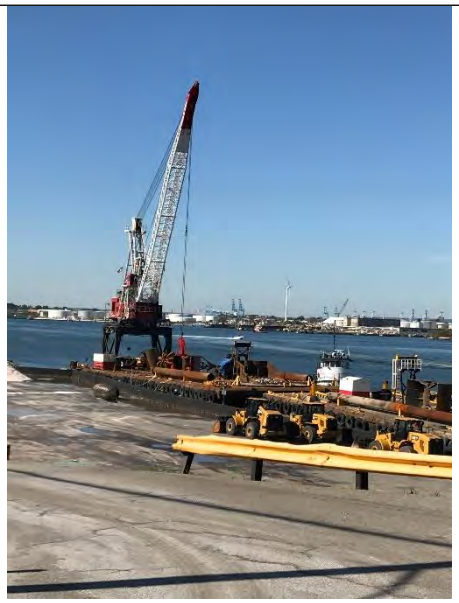
Photo 2: Active construction on the Atlantic Salt property, located: on; and, adjacent to, the eastern portion of the Proposed Alignment of Section 2, in subsection 2B, facing northwest.

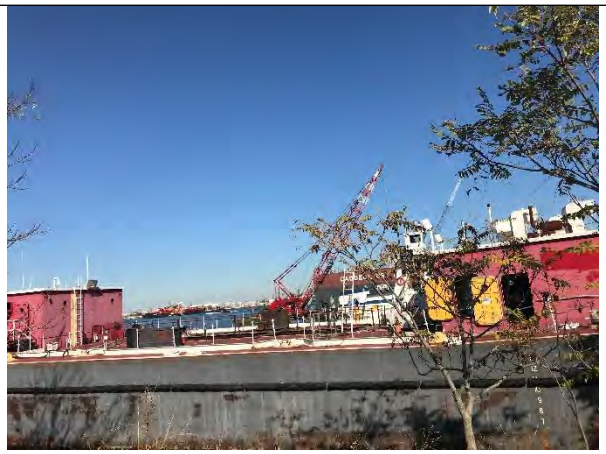
Photo 8: Limited view of the Caddell Dry Dock and Repair facility, located: on; and, adjacent-north to, the western portion of the Proposed Alignment of Section 2, in subsections 2F through 2I, facing east.

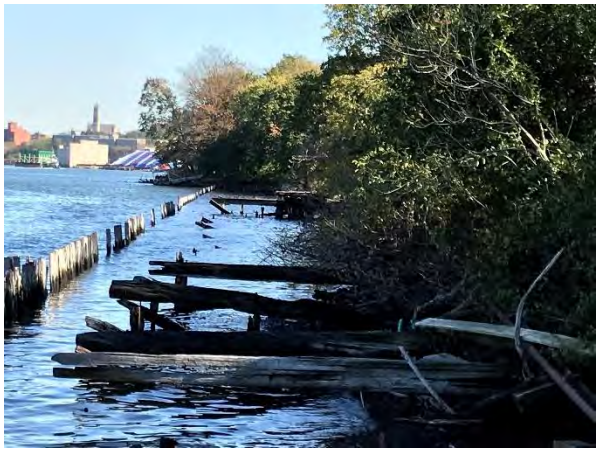
Photo 10: View of two proposed alignment options for the central portion of the Proposed Alignment of Section 2, located: in the water; and, on the vegetated land, in subsections 2C through 2E, facing east.
