Preliminary Review September 29, 2011 Lightning Strike at Jamaica

**Meeting of the Metro-North and Long Island Committees
October 24, 2011**

Overview: 9/29/11 Service Disruption

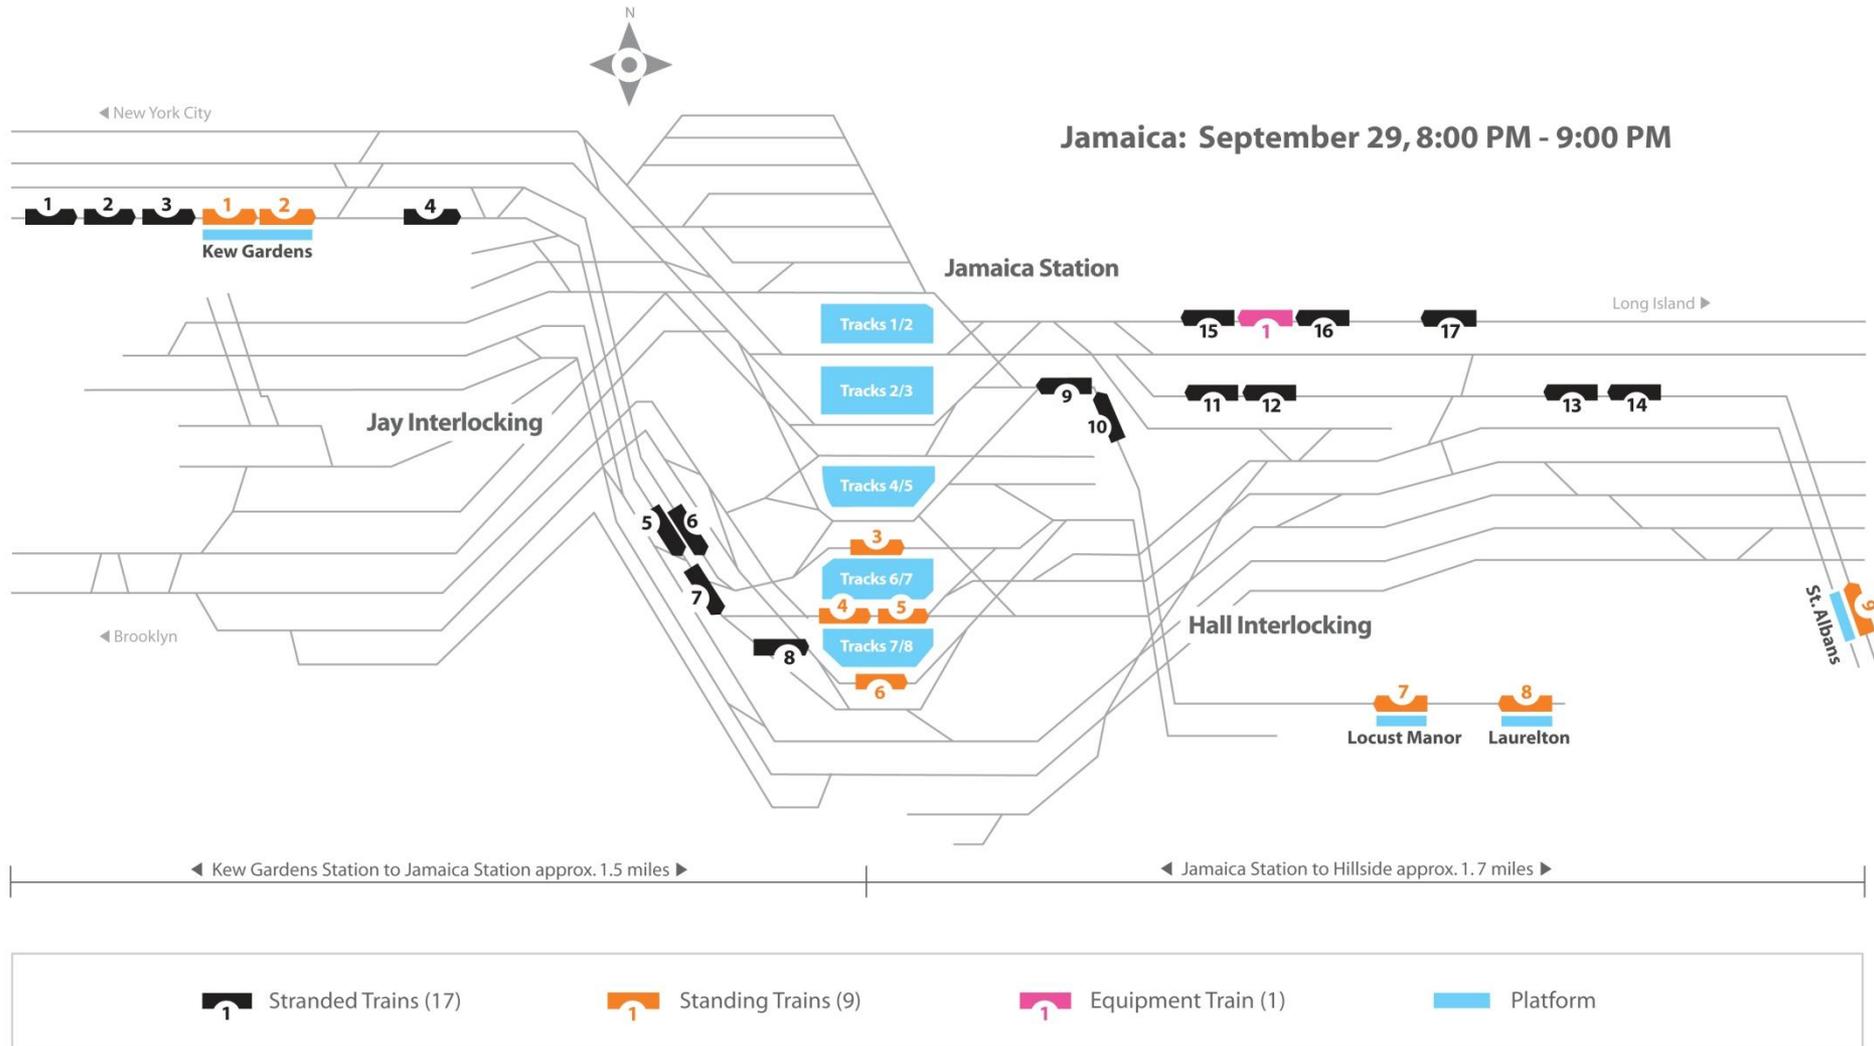
LOCATION OF STANDING AND STRANDED TRAINS AFTER HALL SIGNAL SHUTDOWN

- Service suspended again with loss of Hall signal system. Wherever possible, trains pulled to stations to accommodate customers. 17 trains became stranded.
